**Crail Preservation Society**

## **Mural Monument XIX to the Lindsays of Wormiston, Crail Kirkyard, Crail, Fife**

### **CONDITION REPORT & CONSERVATION STATEMENT**

*AUGUST 2024*

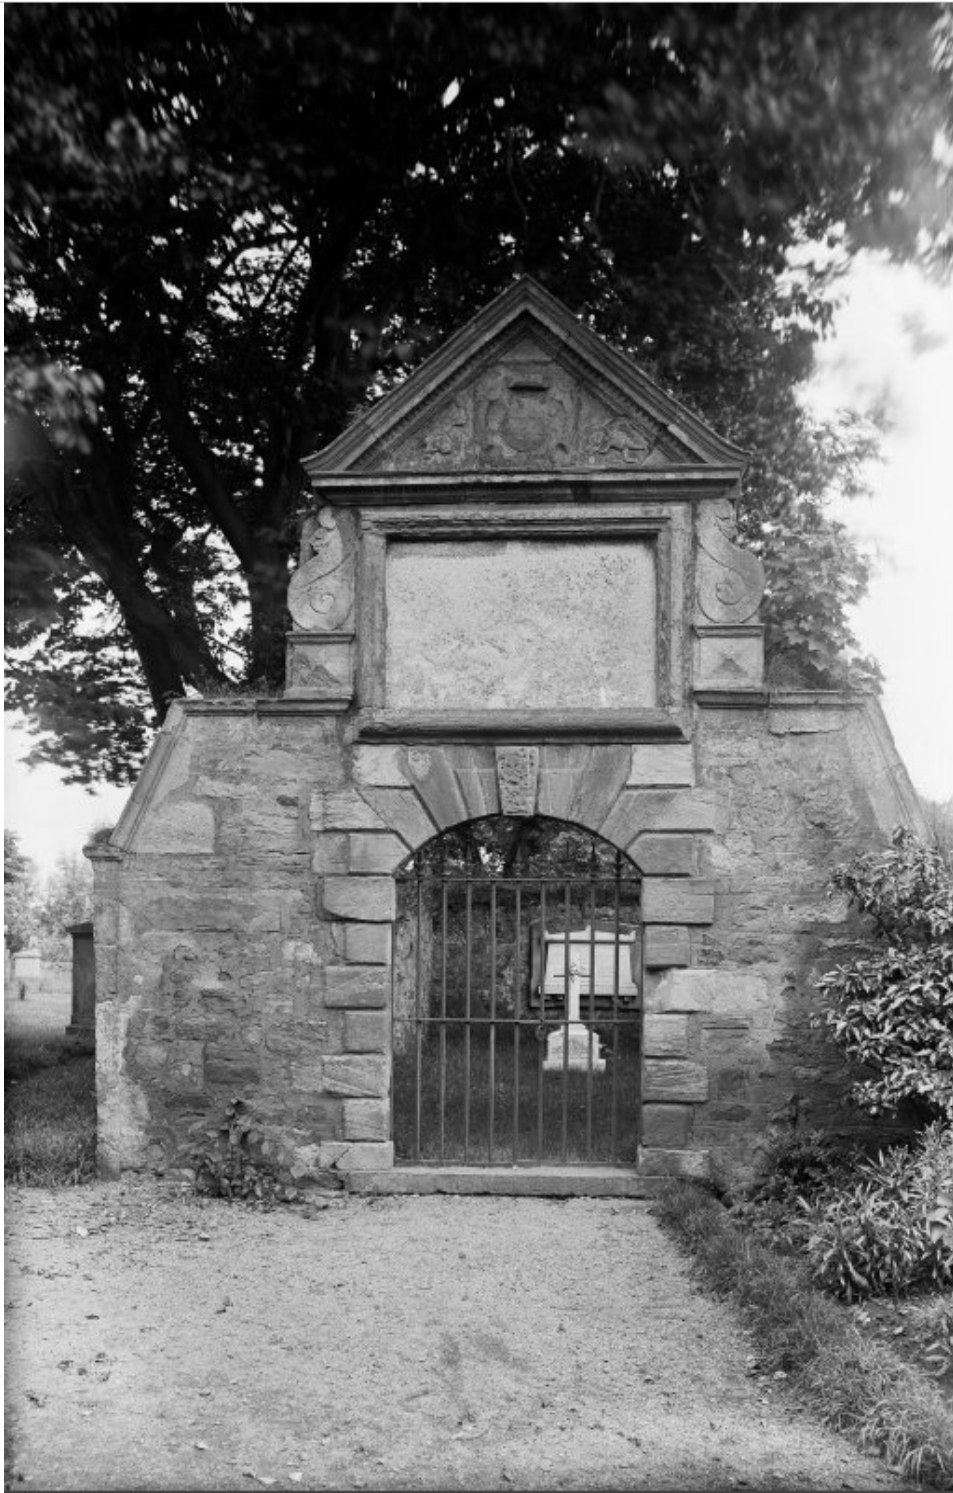
| | <i><b>Chronology of historic surveys and photographic records</b></i> |
|---|---|
| <b>c. 1890</b> | Erskine Beveridge CANMORE( Catalogue No SC 739329) |

| | <i><b>Chronology of historic surveys and photographic records</b></i> |
|---|---|
| | <p>Note: Erskine Beveridge comprehensively recorded and researched the churchyard, including its mural monuments, and his work was published in 1893. This image clearly shows the condition of the principal elevation of the monument at the end of the 19th century.</p> |

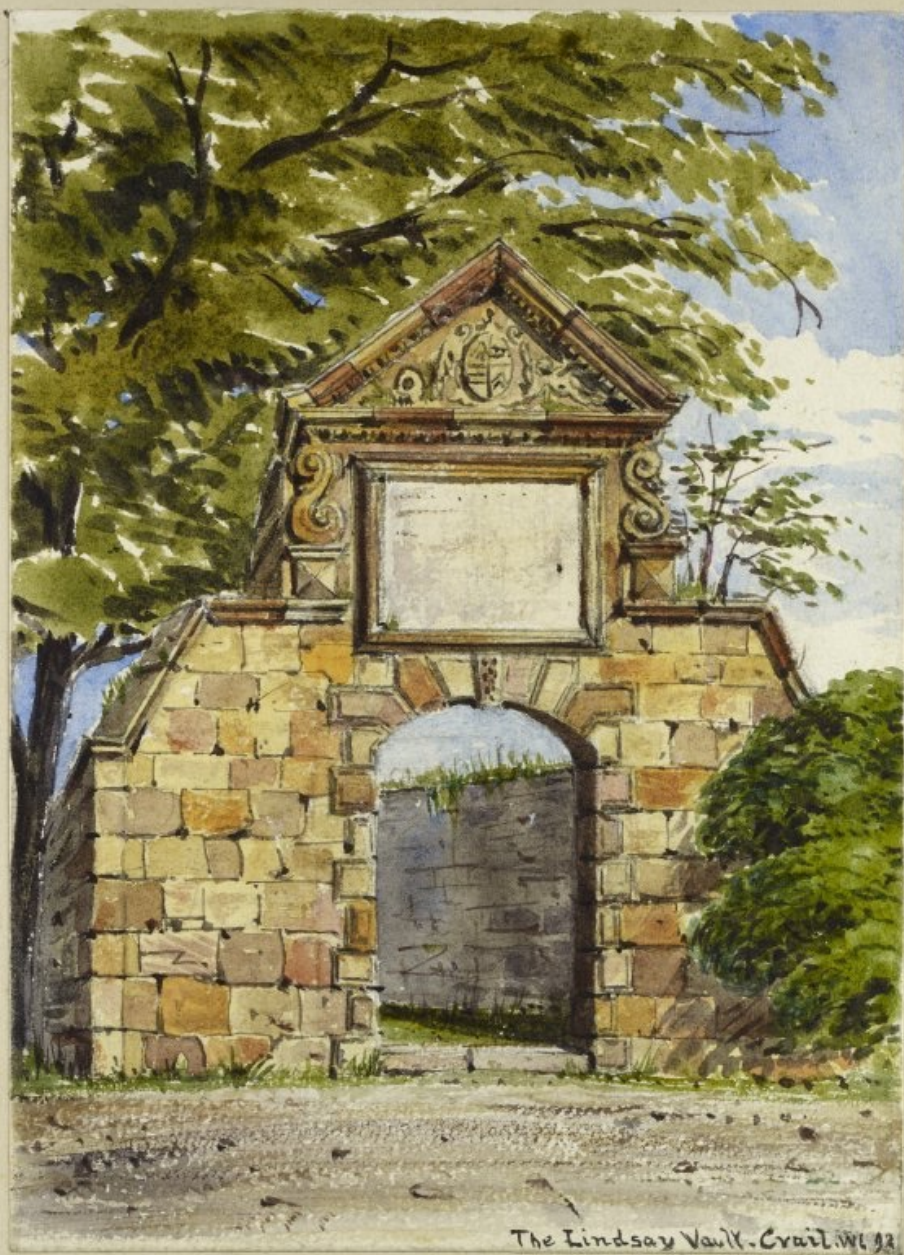
CANMORE Neil Hynd Collection, Catalogue Number: DP 312724

Note: Perspective view of Lindsay of Wormiston Memorial inscribed 'The Lindsay Vault, Crail, WL 92'. Neil Hynd Collection.  
<http://canmore.org.uk/collection/1890026>

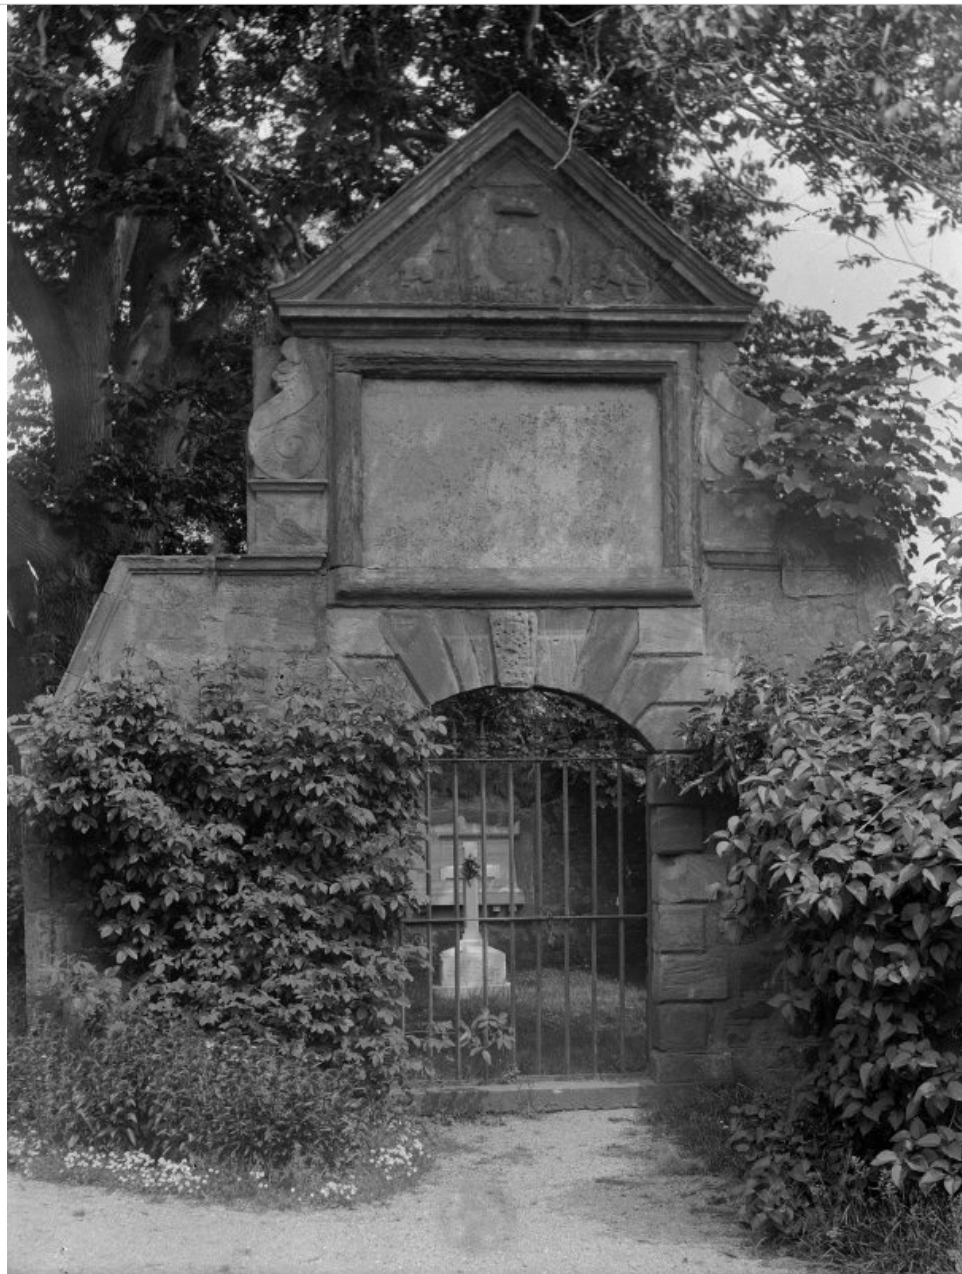
National Art Survey of Scotland photograph Catalogue No: SC 1104678

Note: Lindsay of Wormiston Memorial. Image from the Records of the National Art Survey of Scotland, Edinburgh, Scotland. Date: c.1900.  
<http://canmore.org.uk/collection/1104687>

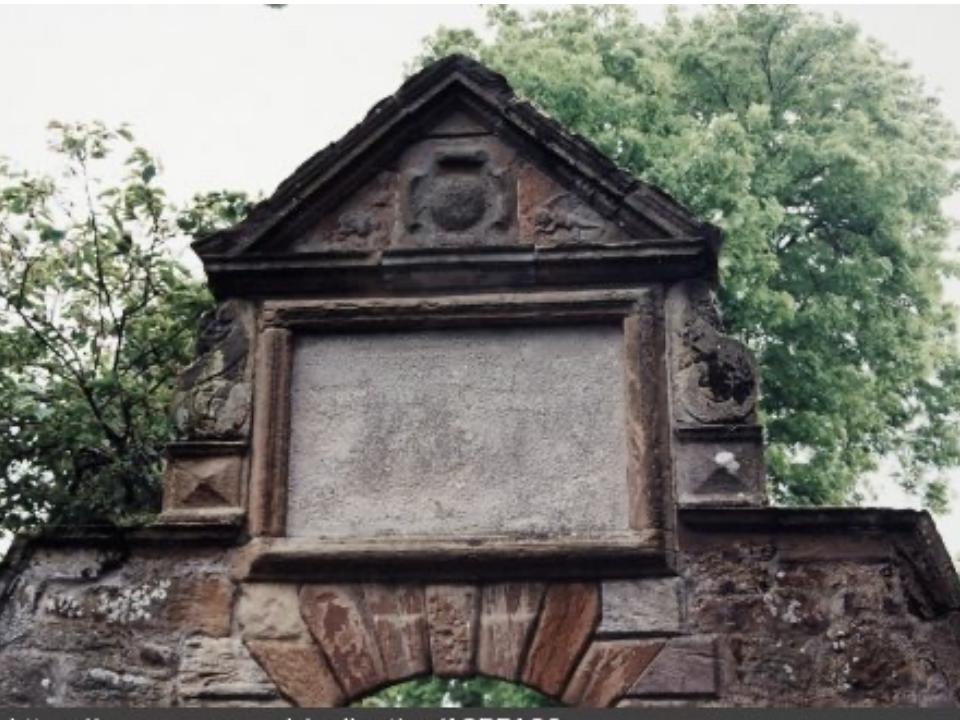
| | <p>Note: Detail of plaque and pediment above enclosure. Stuart Farrell collection dated 8th June 1998.</p> |

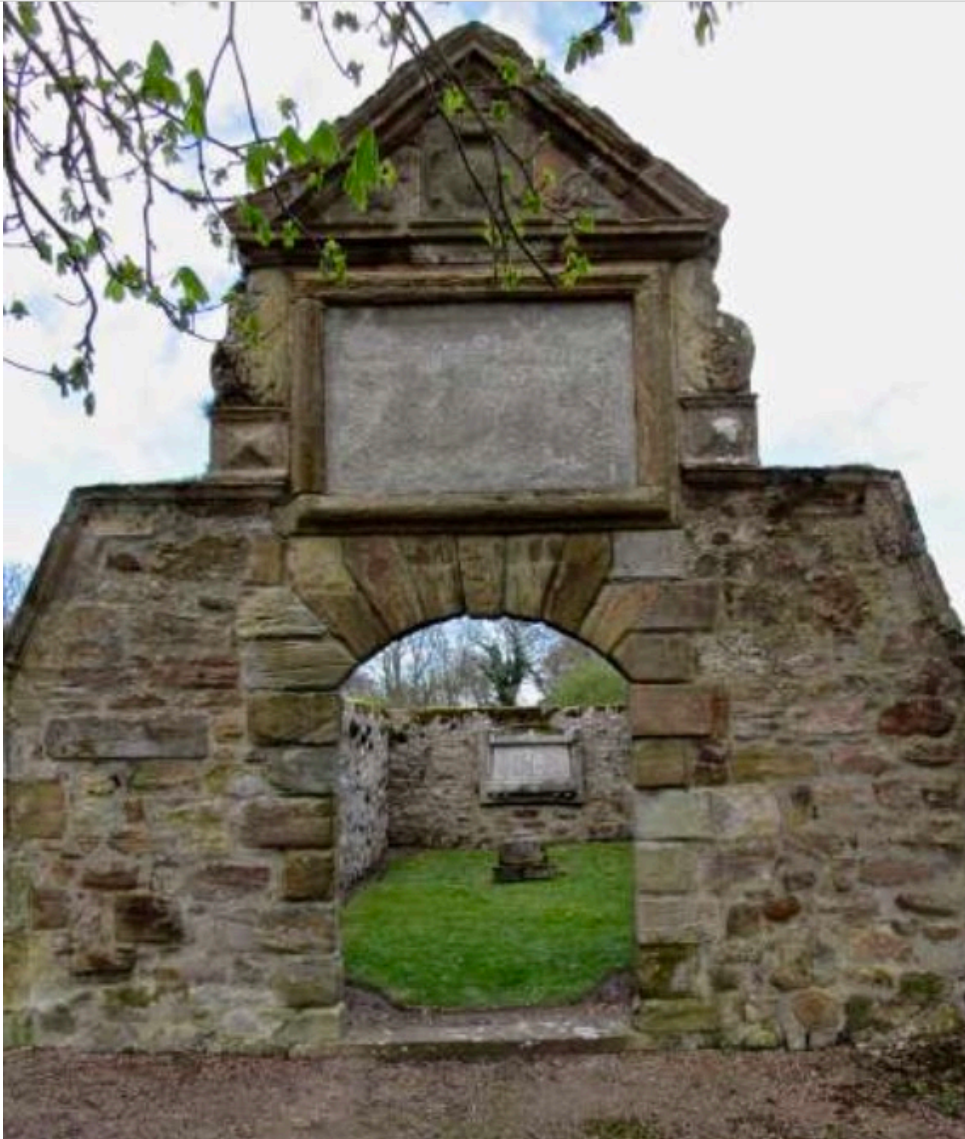
| | <p>Note: The report notes that all carvings are very worn and the inscription panel below the pediment is completely eroded. It recommended the removal of biological growth, including the higher plants on the upper part of the structure; repointing of damaged mortar and open joints and consolidation of the surface of the stone in areas affected by scaling.</p> |

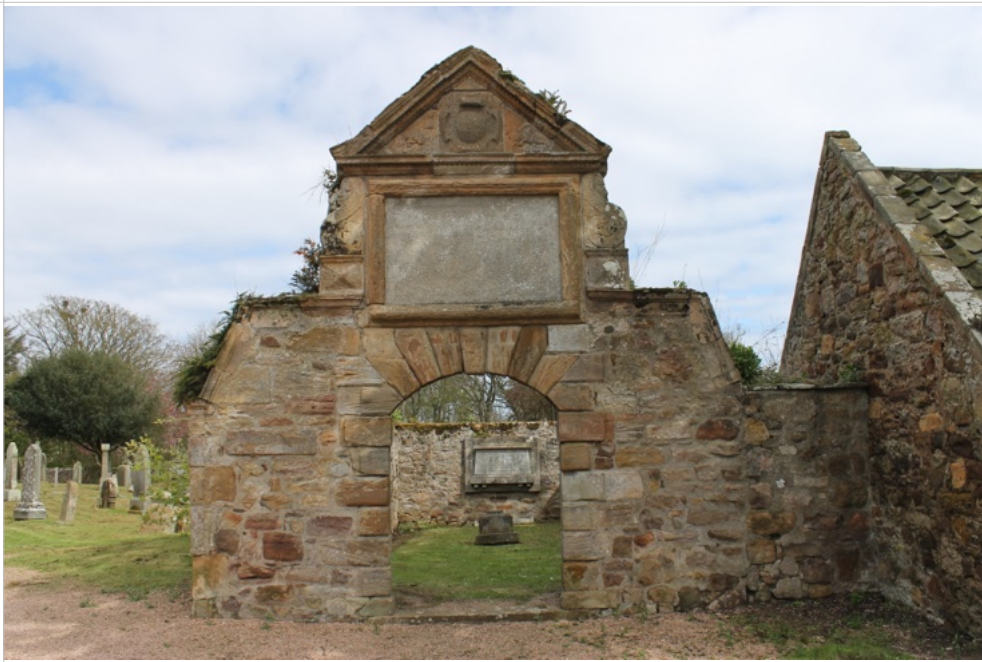
| 2024 | John Renshaw Architects, condition survey 24th April 2024 |

The sandstone pediment, the carved/dressed sandstone around the entrance, and the framing around the panel are all very weathered but appear to be sound with little obvious disaggregation.

There are previous repairs/open cracks at the PL pediment moulding which require attention.

The majority of the cementitious pointing around the sandstone door and central panel has been lost or is failing allowing water ingress.

There are several small delaminations overall especially at the central panel frame which are likely to deteriorate and cause further surface loss. The surface of the central panel has been lost through disaggregation/weathering except for a small area of inscription which is still visible near its centre.

The mortar joints in the rubble masonry monument facade and enclosure walls are pointed with dense cementitious mortars which are exacerbating the erosion/weathering of the sandstone. It is trapping moisture within individual stones which encourages stone decay/disaggregation and the growth of vegetation and mosses which are established along the top of the walls. The cement pointing is also failing at many areas of the interior and exterior of the walls and the root systems of the woody vegetation will cause or exacerbate cracking and structural movement.

Due to the cementitious nature of the pointing throughout the monument it would be prudent to replace it with an appropriate lime mortar, especially around the areas of carved or dressed sandstone to minimise further deterioration.

All vegetation and mosses on the copes, door frame rusticated ashlar, panel and pediment of the principal facade will be removed with wooden tools prior to the removal/lessening of the surface organic growth/ surface grime using nylon brushes, water and an application of D/2 Solutions biocide.

The cementitious pointing to the dressed stone, panel, pediment and copes will be carefully removed, where there is no risk of damage to the carved ashlar stonework and replaced with an appropriate lime mortar.

The delaminations to the carved/dressed stone will be injected with Paraloid B72 (6% in acetone) prior to being filled with Paraloid B72 (10% in acetone), mixed with fine sand, which will be textured and pigmented to match the surrounding stone. The open cracks at the pediment and the stones of the South facing entrance wall, as well as the edges of the remaining fragment of the inscription at the central panel, will be filled and capped in the same way.

The disaggregating stone of the central panel will be carefully brushed back to a solid surface. It may then be concluded that the panel requires further consolidation (following trials) with Silres BS OH 100 stone strengthener.
