## **Mural Monument XVI to Lun, Reid, Chiene families, Crail Kirkyard, Crail, Fife**

## **CONDITION REPORT & CONSERVATION STATEMENT**

*AUGUST 2024*

**JOHN RENSHAW** ARCHITECTS

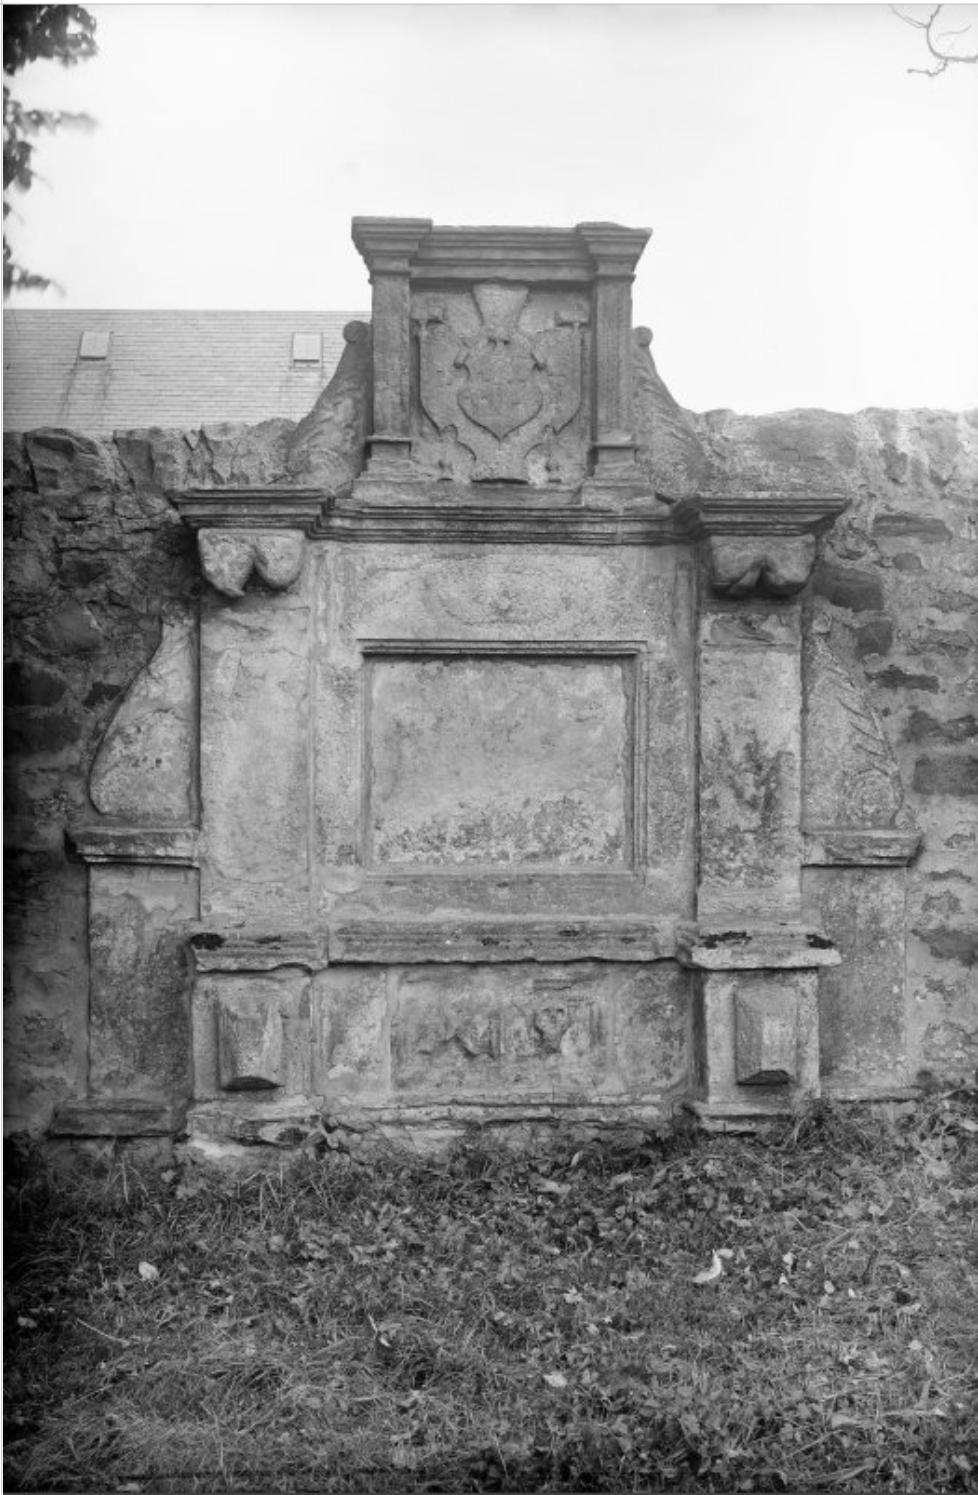
| <b>c. 1890</b> | Erskine Beveridge (CANMORE Catalogue No SC 739314) |

| | Note: Erskine Beveridge record photograph clearly shows the condition of the monument at the end of the 19th century. |

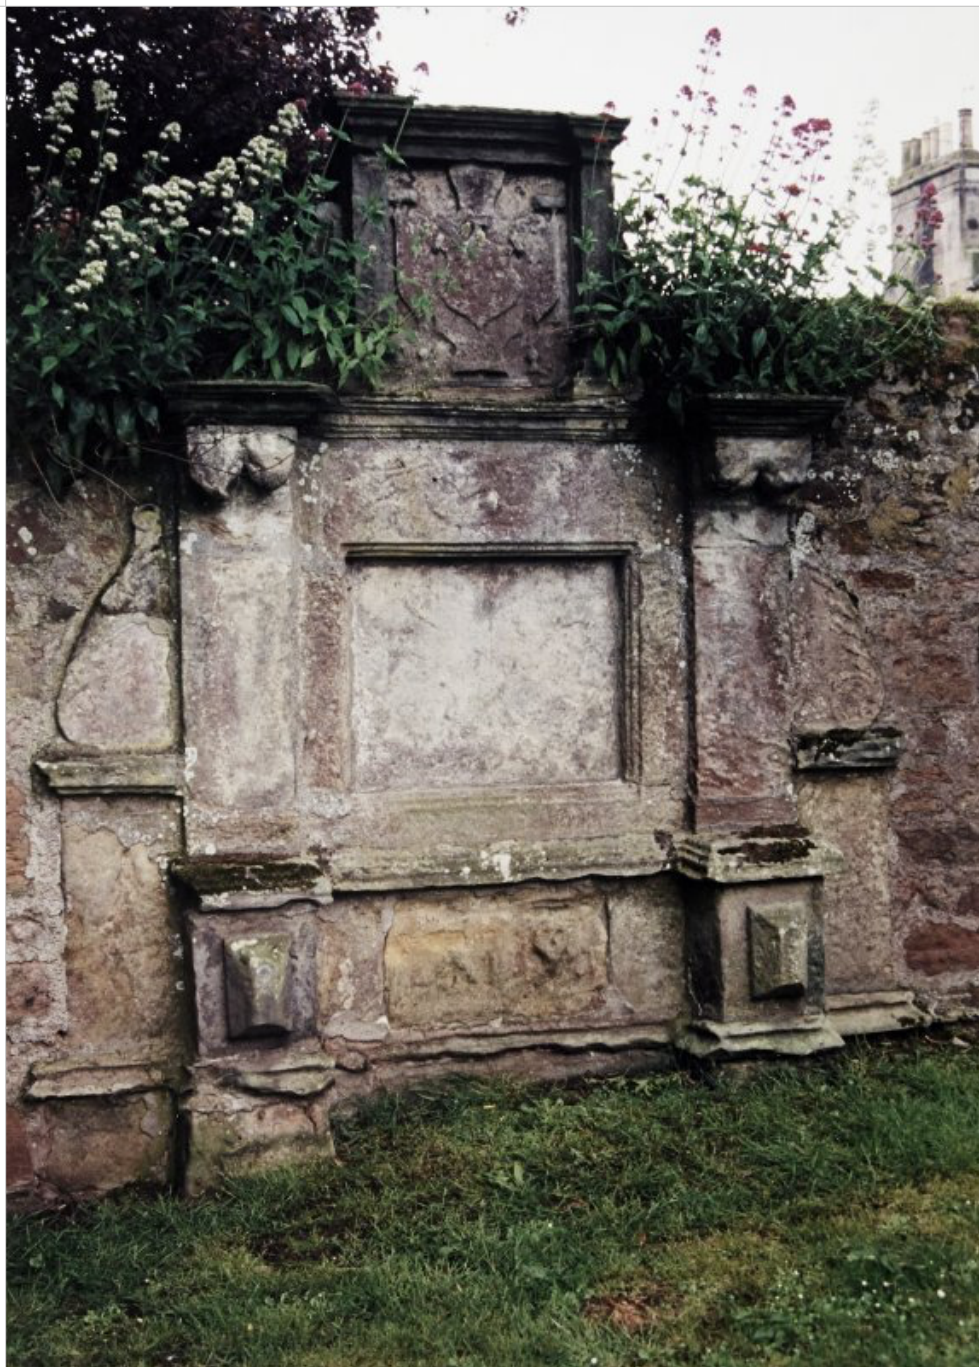
Stuart Farrell collection (CANMORE Catalogue No SC 1855129)

Note: Detail of mural monument c.1998, Crail Parish Churchyard.

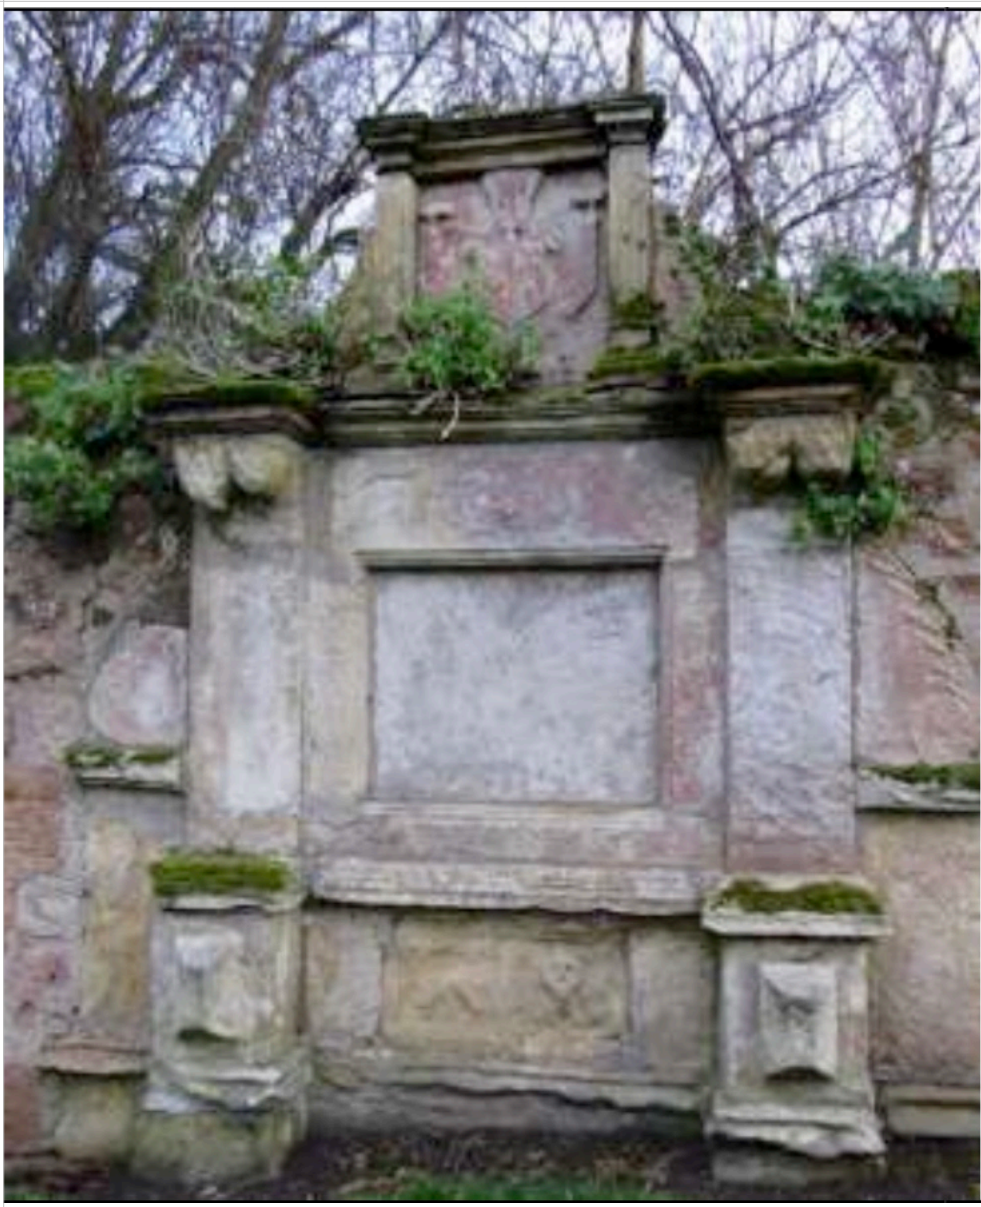
| 2018 | <b>The Mural Monuments of Crail Churchyard Conservation Statement</b><br><b>Dr Susan Buckham &amp; Spectrum Heritage</b> |

| | <p>Note: The Conservation Statement notes that structural damage to its upper stage, threatens its stability and preservation, and poses a risk to the public.</p> |

- i. the careful dismantling of the upper stage of the monument to enable the roots of woody vegetation and saplings to be completely removed without damage to the structure and masonry units of the monument and then rebuilt to match the existing/original profiles and details incorporating stainless steel pins to strengthen the partially free standing *aedicule*;

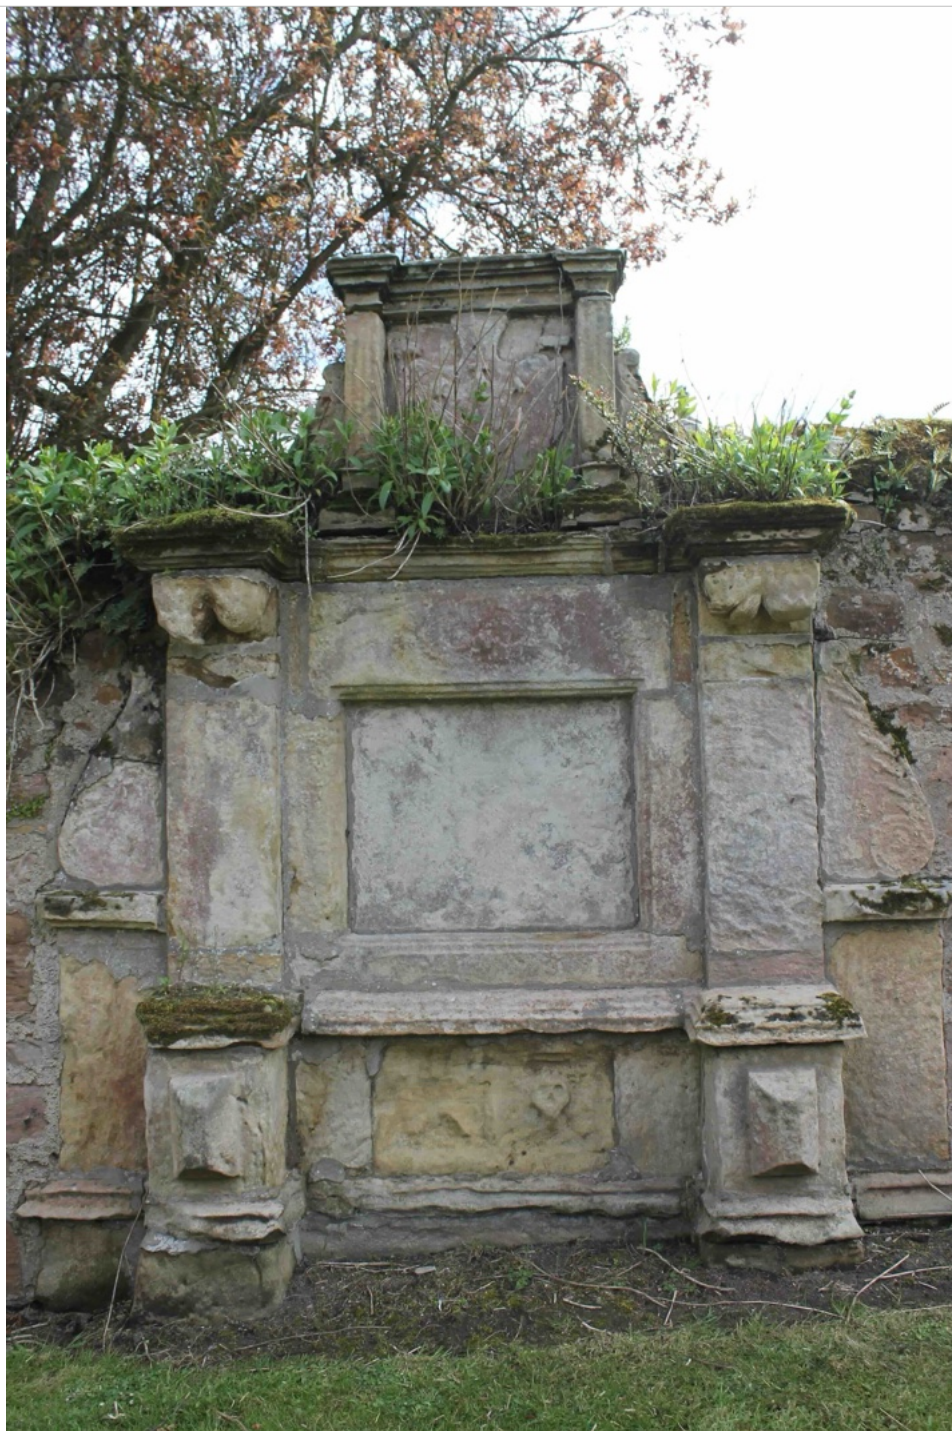
Note: View of mural monument XVI, at time of condition survey carried out by JRA on 24th April 2024.

The upper section or aedicule, which projects above the kirkyard wall, leans backwards as a result of woody plant and tree growth, including red valerian, and ash and sycamore saplings has forced the bed joints to the pilaster bases open and pushing the masonry above backwards; the PR side leans backwards by 5 ° and the PL side is still roughly vertical, so it is twisted and leaning backwards towards the rear gardens. The rubble buttress behind the aedicule is poorly built, possibly unbounded with salvaged brick, rubble stones and dense cementitious capping and pointing mortar. There is also evidence of cut back stems of woody plant growth in the adjoining wall copes with potential to further disrupt the integrity of the wall and monument. This part of the monument is considered to be at risk and poses a safety risk to the owners of the adjoining private gardens.

a) Carefully record each masonry unit, using planning frames, number and dismantle stone by stone to facilitate the complete removal of all saplings, tree roots, woody vegetation and mosses.

Rebuild stonework to the recorded profiles so the completed works exactly match the as existing / original structure. D/2 Solutions biocide would then be applied to all stone surfaces to deter future organic growth.

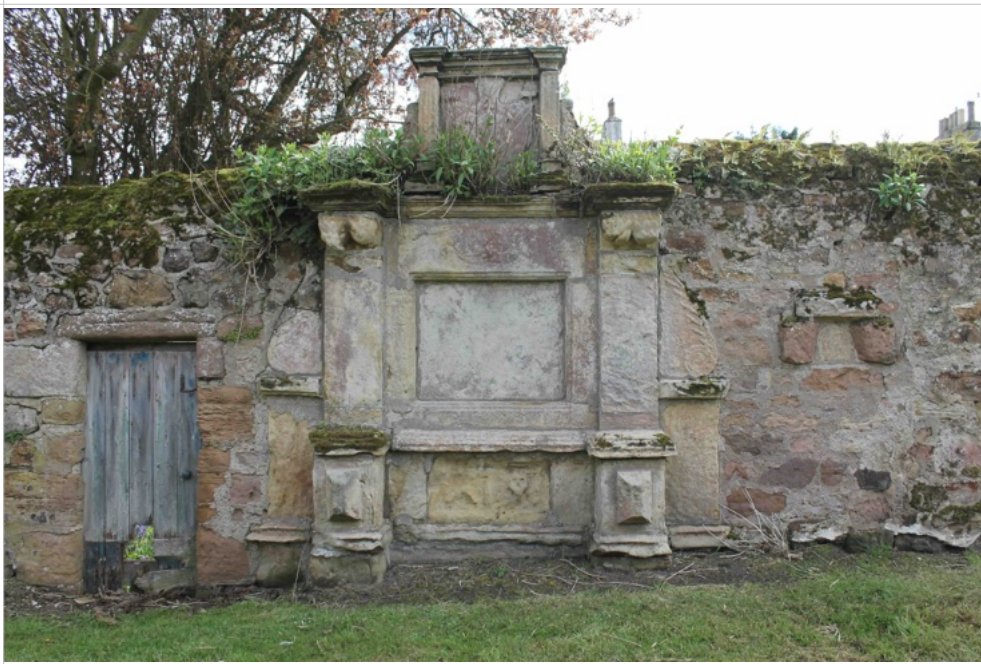
A door opening, with lined, edged and braced timber door is located on its proper right (PR) side (note: proper right denotes the right hand side of the monument or left hand side as one faces towards it). The masonry opening is formed with rebated jambs and roughly shaped stone lintel. An ashlar panel with carved anchor in relief, possibly part of a larger carving, is located above the door lintel. The door leaf measures 750 (w) x 1675 (h) and is in poor condition with small opening cut in into its lower, presumably to provide access for a cat.

| | <p>Note: View of mural monument XVI with adjacent door at time of condition survey carried out by JRA on 24th April 2024.</p> |

- vi. Repairs and decoration of the lined, ledged and braced timber door and frame.
